## NASA Contractor Report 2754

# Real-Time Testing of Titanium Sheet and Extrusion Coupon Specimens Subjected to Mach 2.7 Supersonic Cruise Aircraft Wing Stresses and Temperatures

Tjerand Lunde  
Lockheed-California Company  
Burbank, California

Prepared for  
Langley Research Center  
under Contract NAS1-13649

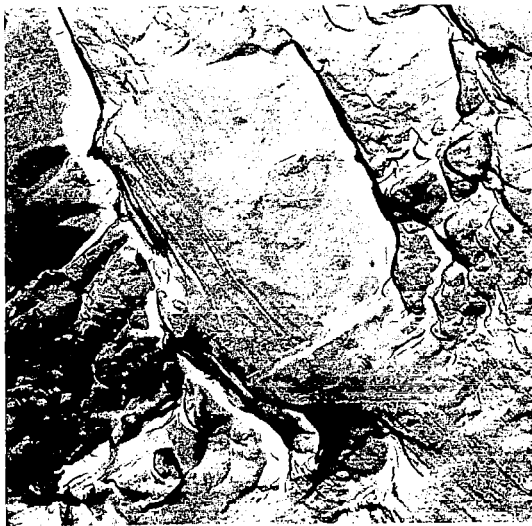
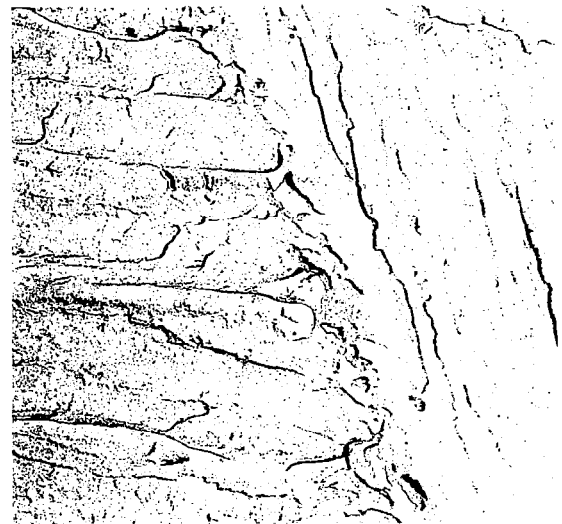
Figure 25. - Electron fractographs from mill-annealed Ti-8Al-1Mo-1V extrusion specimen G-1. Mag. 6500X

(a) and (b) Fatigue striations interrupted by cleavage steps which were predominant in the fatigue regions.

(c) Dimples and second phase particles; and  
(d) Cleavage-type fracture features; in the area adjacent to the larger fatigue region.

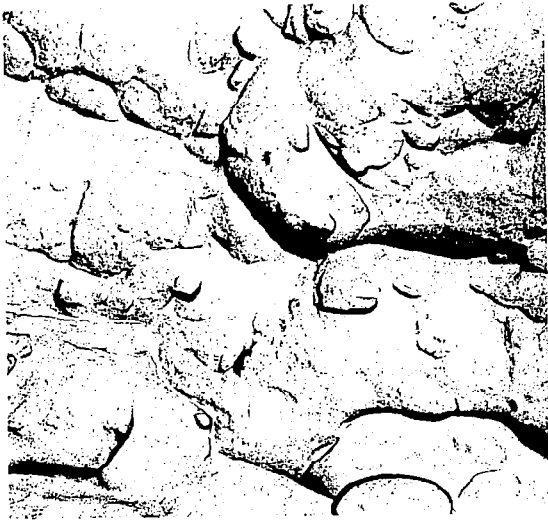
Figure 25. - Concluded.

Well formed dimples: (e) In an area half-way along the shear regions; and  
(f) At the end of the shear regions.

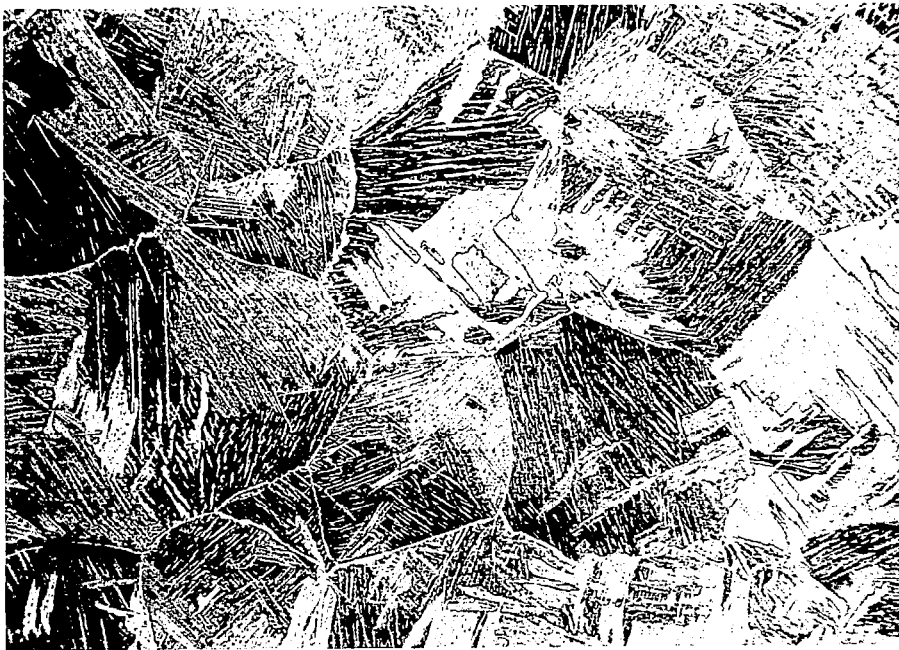
Figure 29. -- Typical microstructures for the mill-annealed Ti-8Al-1Mo-1V extrusion specimens.

(a) Grip area (specimen H-3). Mag. 200X

(b) Fatigue area near the center hole. Mag. 450X

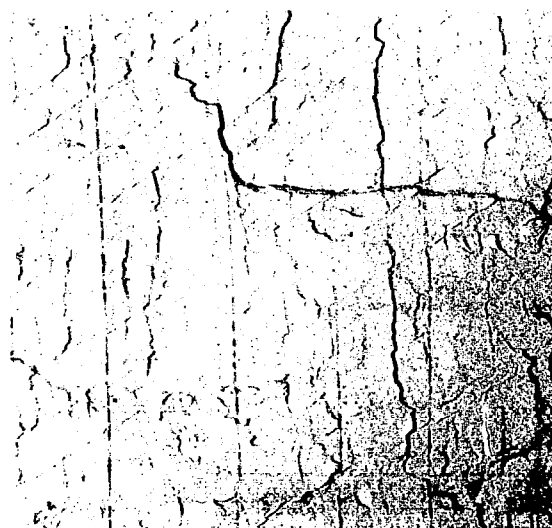
Figure 30. - Electron fractographs from mill-annealed Ti-8Al-1Mo-1V extrusion specimen H-3. Mag. 6500X

(a) Fatigue striations with occasional striation cracking found in the oxidized fatigue area; and (b) Cleavage rupture mode found in the rapid overload failure area.

(c) and (d) Cleavage-type fracture features found intermixed with fatigue striations in the fatigue region.

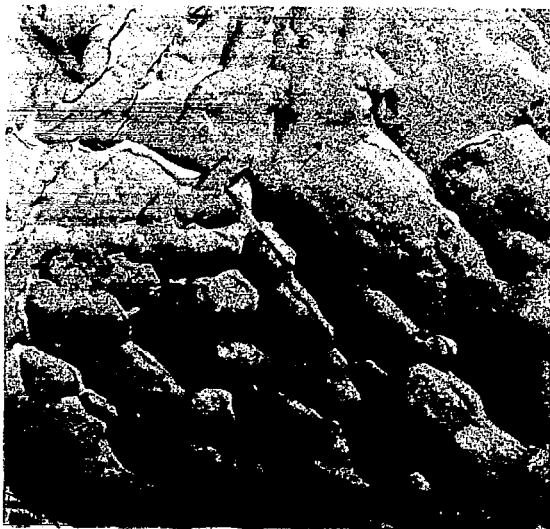
Figure 30. - Concluded.

(i) Dimple rupture mode found in areas adjacent to the fatigue region and mid-way towards the specimen outer edge; and (j) Fatigue striations found in area adjacent to the visual fatigue region.

(k) and (l) Dimples in the fracture surface opposite the fatigue crack side of the hole.

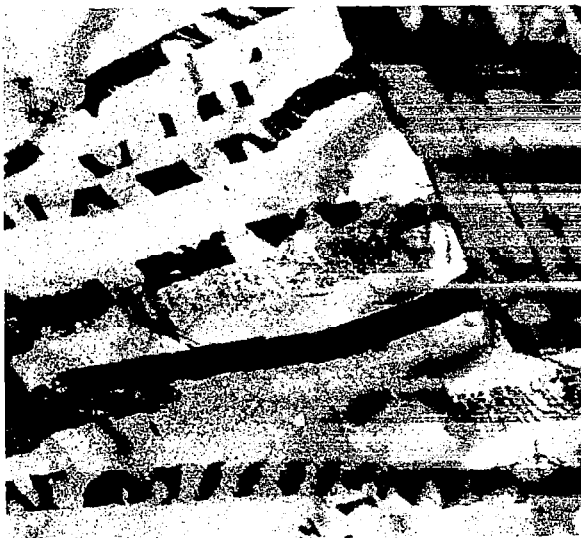
Figure 31. - Transmission electron micrographs from mill-annealed Ti-8Al-1Mo-1V extrusion specimen H-3.

(a) Parallel lamellae separated by relatively low angle boundaries with clear grain interiors; and (b) Prominent grain boundary (upper left to lower right) with numerous partial dislocations and associated stacking faults evident in the right grain.

(c) Parts of two grains with stacking faults and several dislocation pile-ups; and (d) High magnification electron micrograph of area with apparent second phase particles interconnected by dislocations.
